INDOOR AIR QUALITY ASSESSMENT

**Hadley Elementary School
24 Redington Street
Swampscott, Massachusetts**

Prepared by:
Massachusetts Department of Public Health
Bureau of Environmental Health Assessment
April, 2002

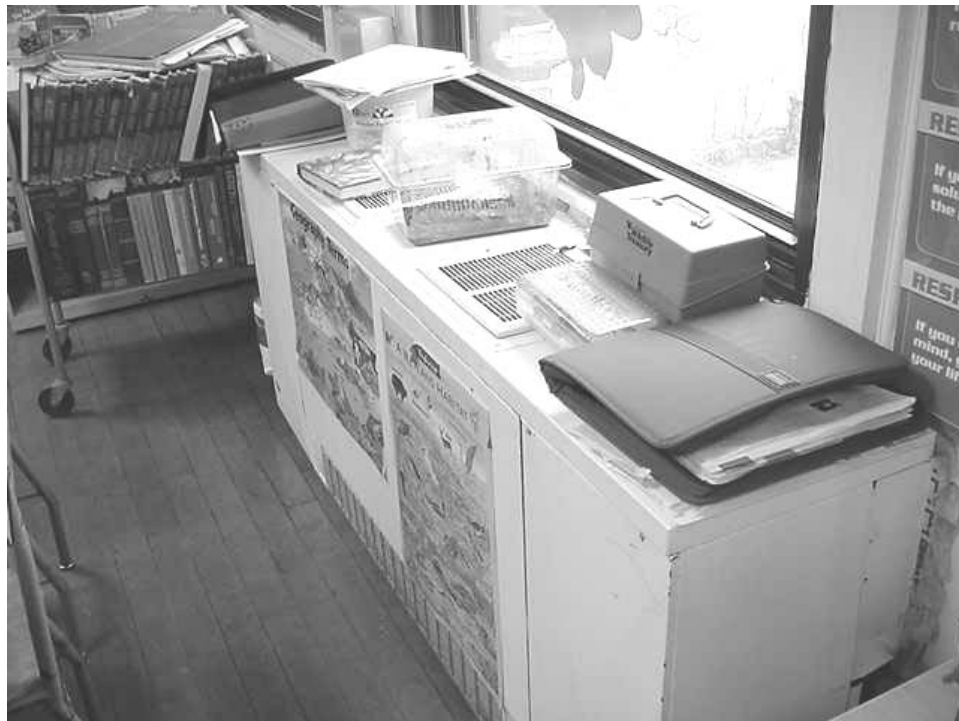
Picture 2

Ventilation in the 1911 building was originally provided by a forced hot air system. This system was intentionally abandoned and replaced by a mechanical ventilation system. Fresh air in classrooms is currently supplied by a unit ventilator (univent) system (see Picture 2). Univents draw air from outdoors through a fresh air intake located on the exterior walls of the building (see Picture 3) and return air through an air intake located at the base of each unit ([see Figure 1](#)). Fresh air and return air are mixed, filtered, heated and provided to classrooms through a fresh air diffuser located in the top of the unit.

Univents were deactivated in a number of classrooms surveyed (see Tables). Obstructions to airflow, such as books, papers and posters on top of univents, as well as bookcases, tables and desks in front of univent returns, were seen in a number of classrooms (see Pictures 2 & 4). To function as designed, univents and univent returns

Example of Classroom Univent Retrofitted into 1911 Building and in 3rd Floor of Annex

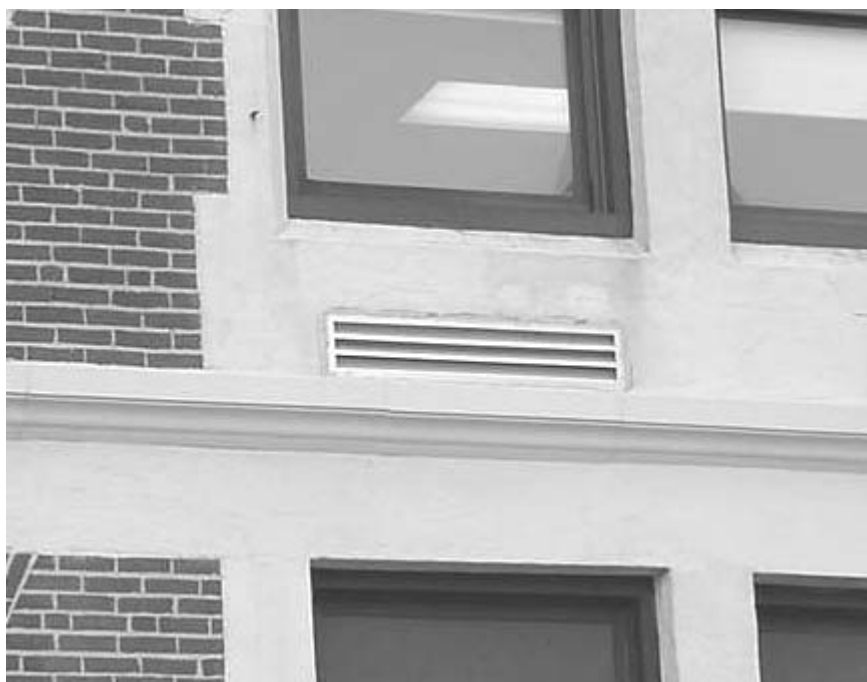
Picture 3

Univent Fresh Air Intake

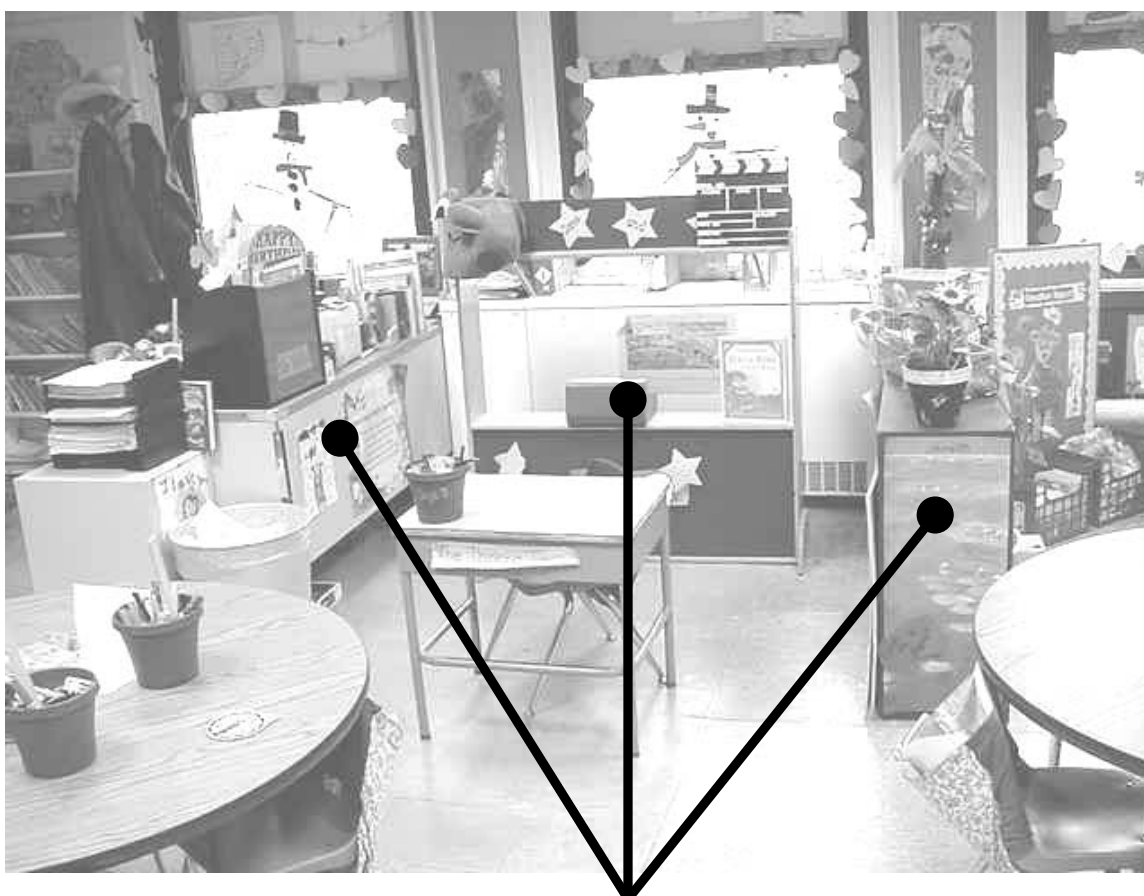
Picture 4

must remain free of obstructions. Importantly, these units must be activated and allowed to operate during hours of school occupation.

Univent Airflow Obstructed by Barriers in Front of Unit as Well as on Either Side

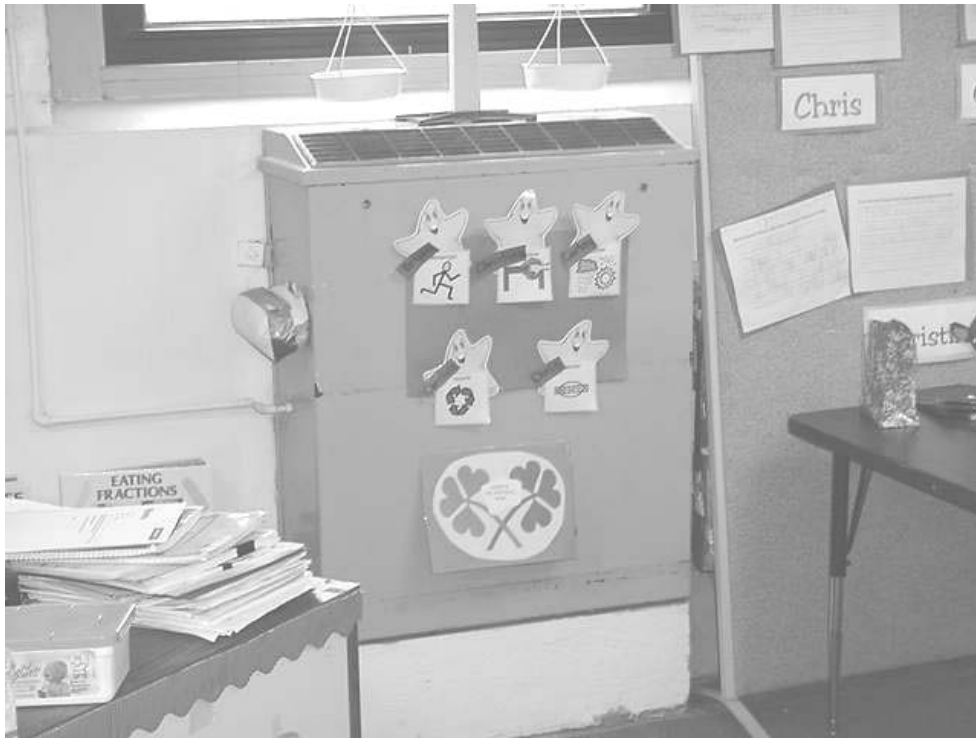
Picture 5

The annex has univents of two different vintages. The annex building's third floor classrooms are ventilated by univents similar to those installed in the original building. Third floor univents were operating during the assessment. The first and second floors of the annex building are equipped with univents originally installed during the construction of the annex. These 1915 univents are not used (see Picture 5).

1915 Univent in Annex Building

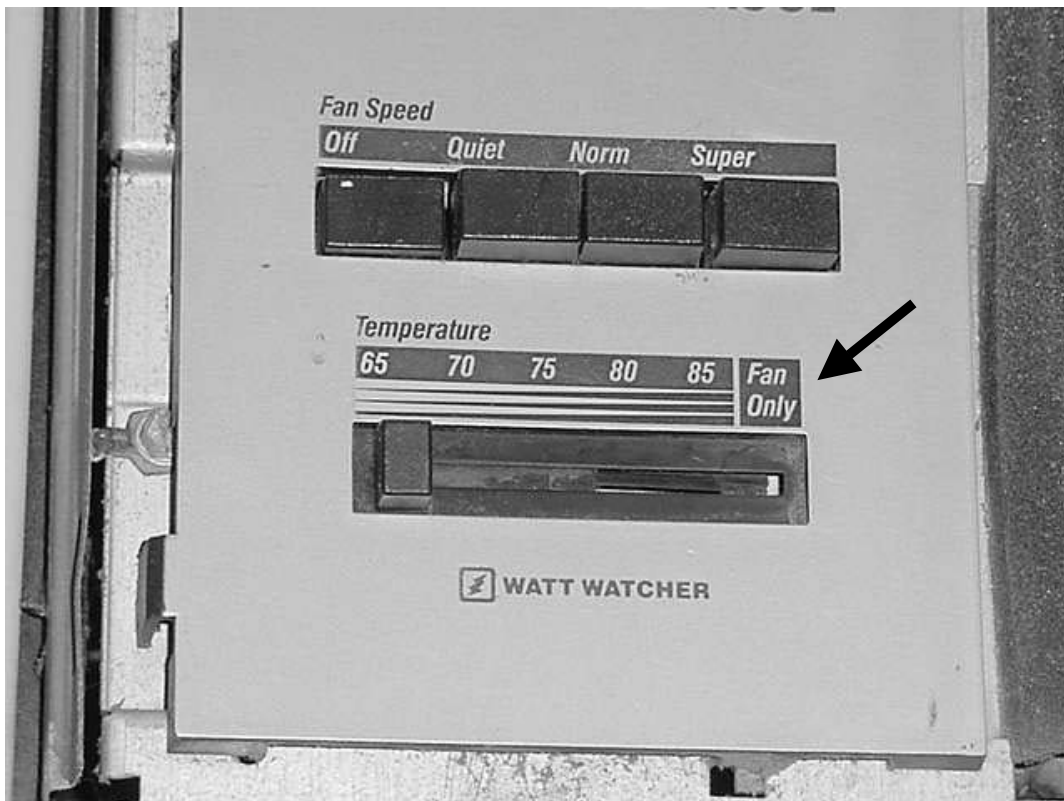
Picture 6

Some classrooms are equipped with window-mounted air conditioners (WAC). These units have a "fan only" option (see Picture 6), which introduces outside air without conditioning it. Classrooms without functioning univents should utilize these WACs to supplement open windows to provide fresh air.

Control Panel for Window-Mounted AC; Note “Fan Only” Setting

8. Operate WACs in the “fan only” mode in classrooms without operating univents to provide fresh air.
9. For buildings in New England, periods of low relative humidity during the winter are often unavoidable. Therefore, scrupulous cleaning practices should be adopted to minimize common indoor air contaminants whose irritant effects can be enhanced when the relative humidity is low. To control for dusts, a high efficiency particulate arrestance (HEPA) filter equipped vacuum cleaner in conjunction with wet wiping of all surfaces is recommended. Avoid the use of feather dusters. Drinking water during the day can help ease some symptoms associated with a dry environment (throat and sinus irritations).

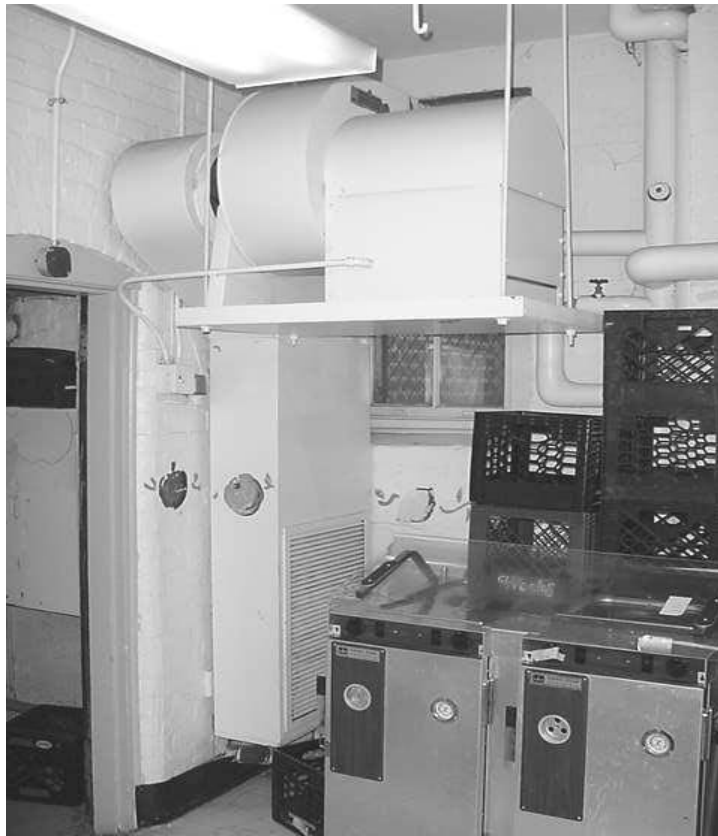
Picture 7

The cafeteria is equipped with a ceiling-mounted univent for fresh air and a local mechanical fan to exhaust air (see Picture 7). This equipment is reportedly not operated during periods of occupancy. BEHA staff recommended to school maintenance staff that the ventilation equipment be operated during periods of cafeteria occupancy.

Local Exhaust Fan in Cafeteria

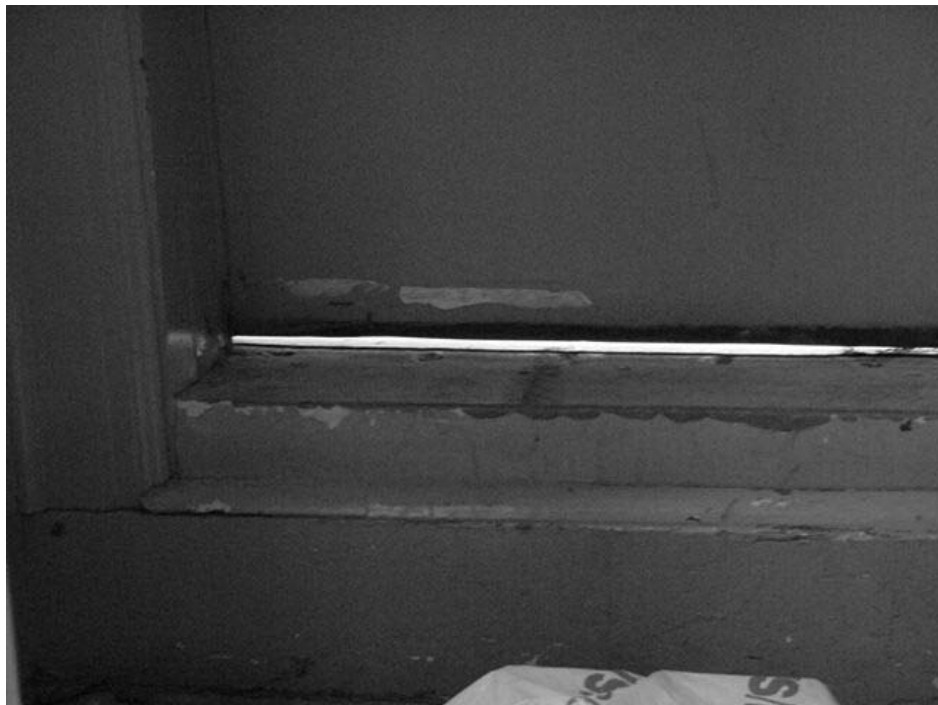
Picture 8

Space beneath Door to Roof in Ms. Remare's Room

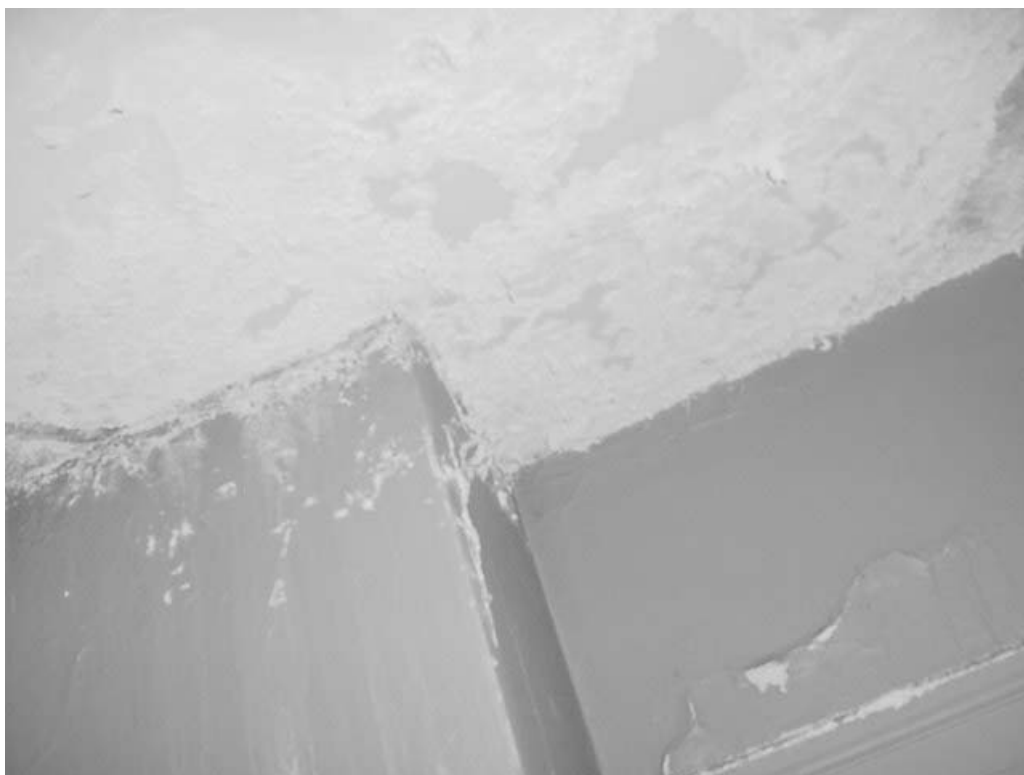
Picture 9

Water-damaged ceiling tiles and wall plaster were observed in several areas of both buildings, which may indicate either a current or historic water penetration problem. Efflorescence (i.e., mineral deposits) and peeling paint were observed above the ceiling tiles in the coatroom of Ms. Salemi's classroom (see Pictures 9 & 10). Efflorescence is a characteristic sign of water damage to building materials such as brick or plaster, but it is not mold growth. As moisture penetrates and works its way through mortar around brick, water-soluble compounds in bricks and mortar dissolve, creating a solution. As the solution moves to the surface of the brick or mortar, water evaporates, leaving behind white, powdery mineral deposits. This condition indicates that water from the exterior has penetrated into the building. Water-damaged building materials, such as painted wall plaster and ceiling tiles, can serve as a medium to support mold growth, especially if wetted repeatedly. This was reported to be an area of chronic water penetration. It was reported that the brickwork of the exterior wall of the building was repointed to prevent further water damage. BEHA staff conducted moisture testing of wall plaster in this area. No elevated moisture levels or visible mold growth were observed in walls with efflorescence at the time of the assessment.

Peeling Paint and Water-Damaged Ceiling Plaster above Ceiling Tiles in Ms. Salemi's Coat Closet

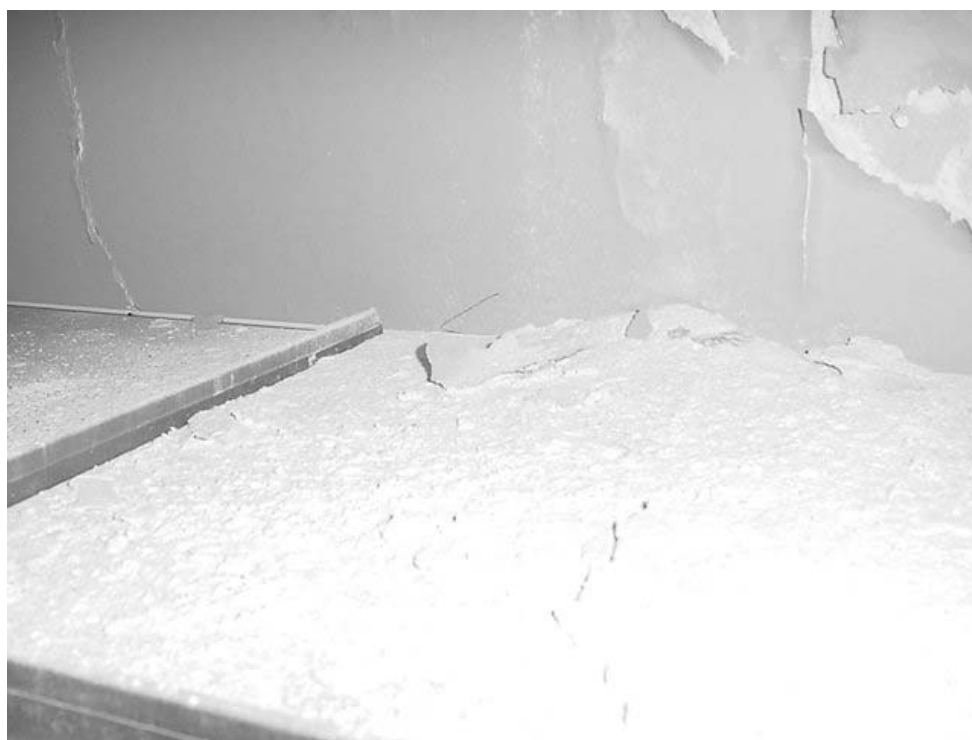
Picture 10

Accumulated Mineral Deposits from Water-Damaged Ceiling Plaster above Ceiling Tiles in Ms. Salemi's Coat Closet

18. Clean chalkboards and trays regularly to prevent the build-up of excessive chalk dust.
19. Remove accumulated mineral deposits from above ceiling tiles in Ms. Salemi's coat closet/room. Monitor this area periodically for water penetration.

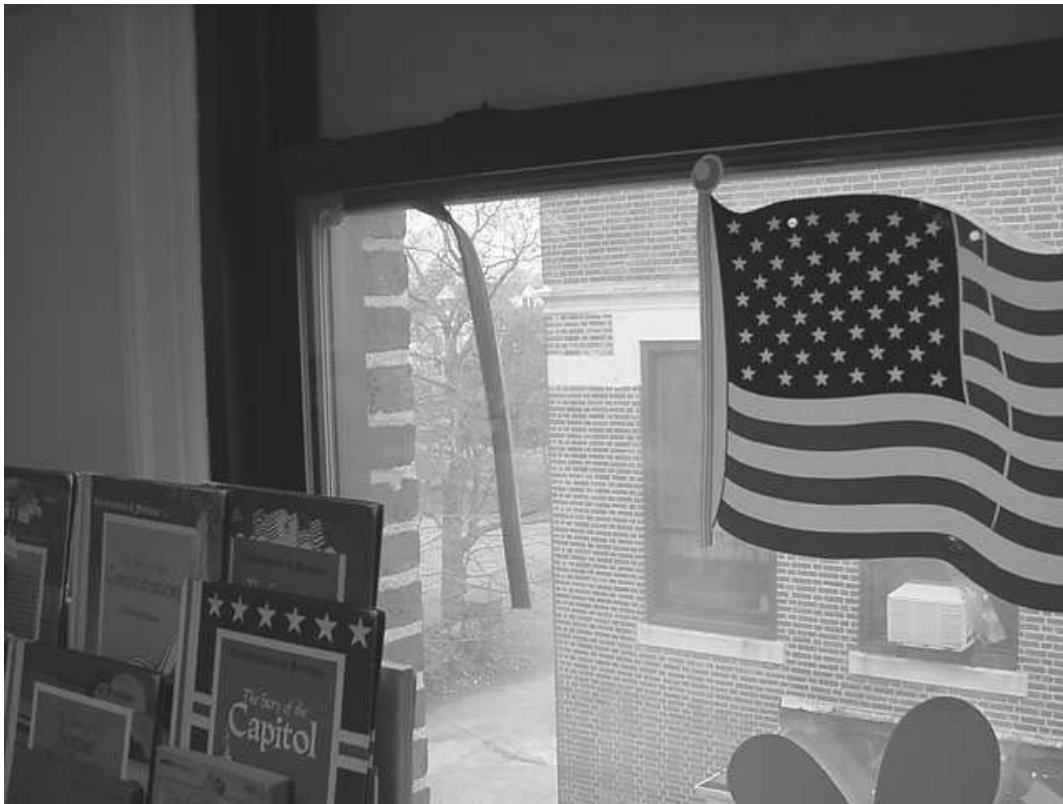
Picture 11

Caulking/weather stripping around window panes in Ms. Palleschi's classroom was failing (see Picture 11). Water penetration through windows/frames can lead to mold

growth under certain conditions. Replacement of caulking and repairs of window leaks are necessary to prevent further water penetration.

Failing Caulking/Stripping in Ms. Palleschi's Classroom

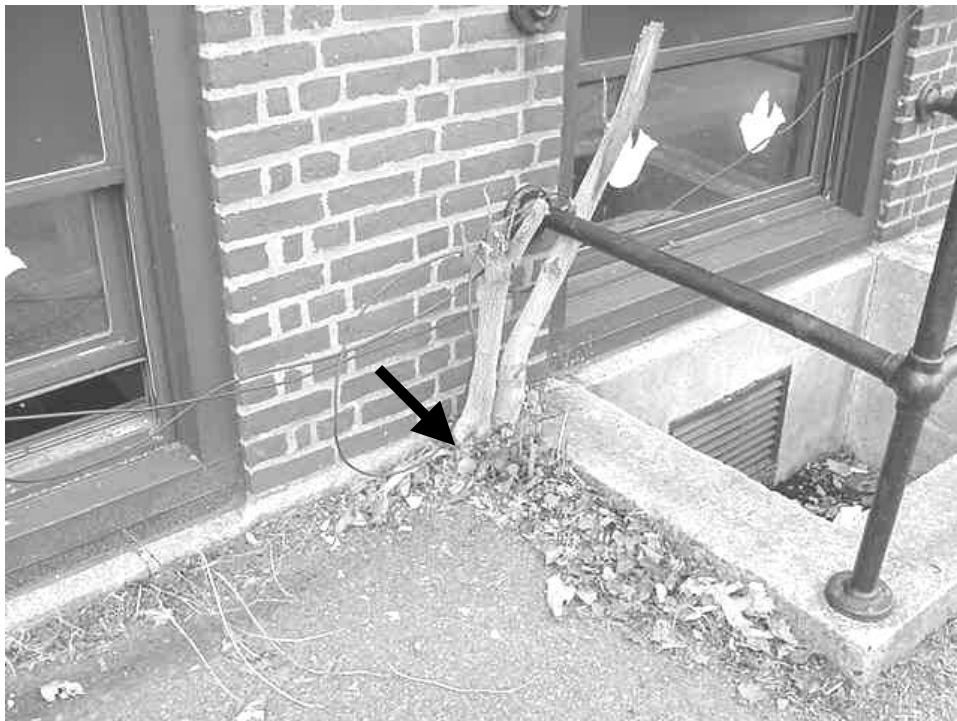
Picture 12

Around the perimeter of the building small trees/stumps and other plants were growing in the tarmac/exterior wall junction (see Picture 12). The growth of roots against the exterior walls as well as spaces between the tarmac and exterior walls of the building can bring moisture in contact with wall brick and eventually lead to cracks and/or fissures in the foundation below ground level. Spaces can bring moisture in and eventually lead to cracks and/or fissures in the foundation.

Small Trees Growing against the Foundation of the Building

13. Remove plant growths against the exterior wall/foundation of the building to prevent water penetration.
14. Consider relocating photocopiers and lamination machines to opposite side of auditorium once mechanical ventilation is activated.

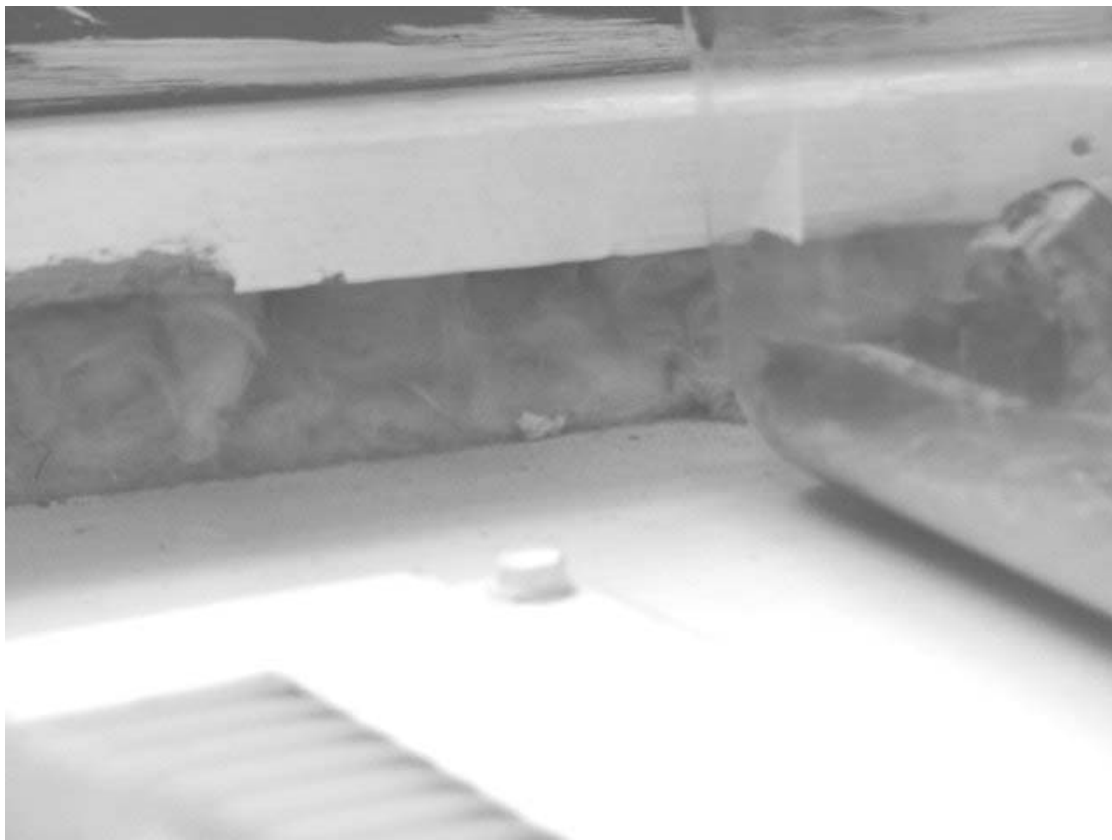
Picture 13

Several other conditions were noted during the assessment that can affect indoor air quality. Exposed fiberglass insulation was observed around univents in a number of classrooms (see Picture 13). Fiberglass insulation can be a source of skin, eye and respiratory irritation to sensitive individuals.

Exposed Fiberglass around Classroom Univent

16. Encapsulate exposed fiberglass insulation around univents and pipes to avoid the aerosolization of fiberglass fibers.
17. Store chemicals and cleaning products properly and out of the reach of students.

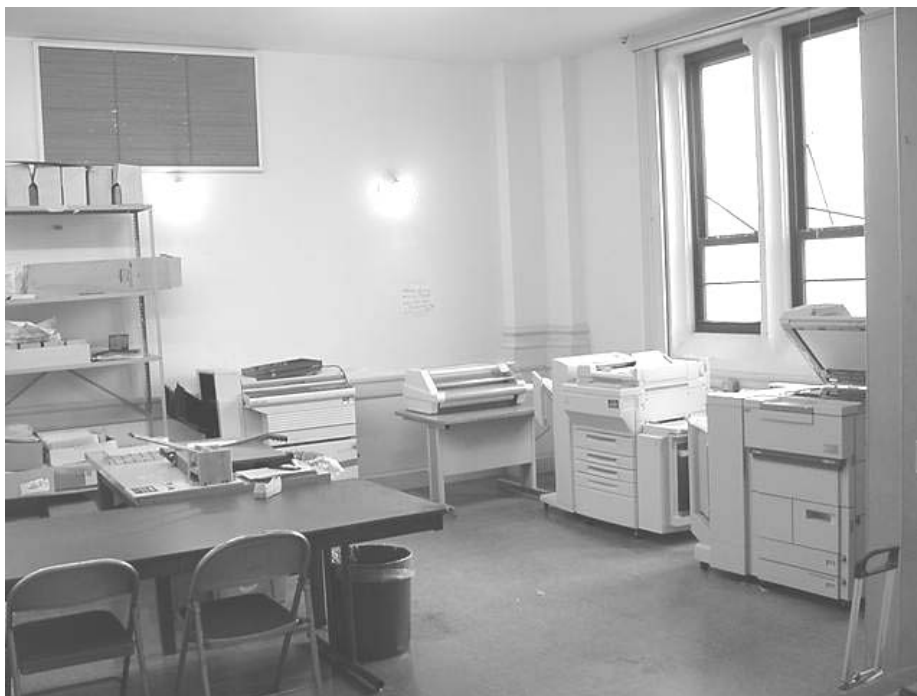
Picture 14

The rear right corner of the auditorium contained a lamination machine, photocopier and other equipment (see Picture 14). Volatile organic compounds (VOCs) and ozone can be produced by photocopiers, particularly if the equipment is older and in frequent use. Ozone is a respiratory irritant (Schmidt Etkin, D., 1992). Lamination machines can produce irritating odors during use. This area is not equipped with local exhaust ventilation to remove excess heat and odors generated by this equipment. The opposite side of the auditorium (rear left) has a wall-mounted exhaust vent. Once the building is provided with mechanical exhaust ventilation, the equipment should be re-located to this area.

Photocopiers and Lamination Machines in Rear of Auditorium

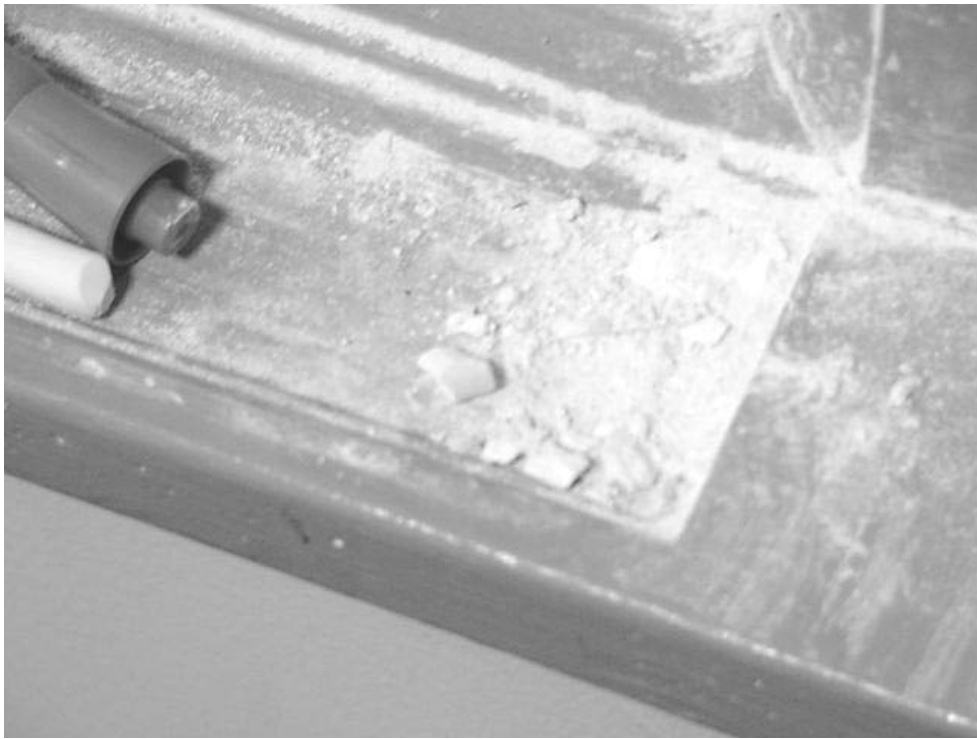
Picture 15

Accumulated chalk dust was noted in several classrooms (see Picture 15). Chalk dust is a fine particulate, which can become easily aerosolized and serve as a source of eye and respiratory irritation. A number of classrooms contained dry erase boards and dry erase board markers. Materials such as dry erase markers and dry erase board cleaners may contain volatile organic compounds (VOCs), (e.g. methyl isobutyl ketone, n-butyl acetate and butyl-cellusolve) (Sanford, 1999). Cleaning products were found on floors, counter-tops and beneath sinks in a number of classrooms. Cleaning products and dry erase board markers and cleaners contain chemicals that can be irritating to the eyes, nose and throat of sensitive individuals.

Accumulated Chalk Dust in Classroom

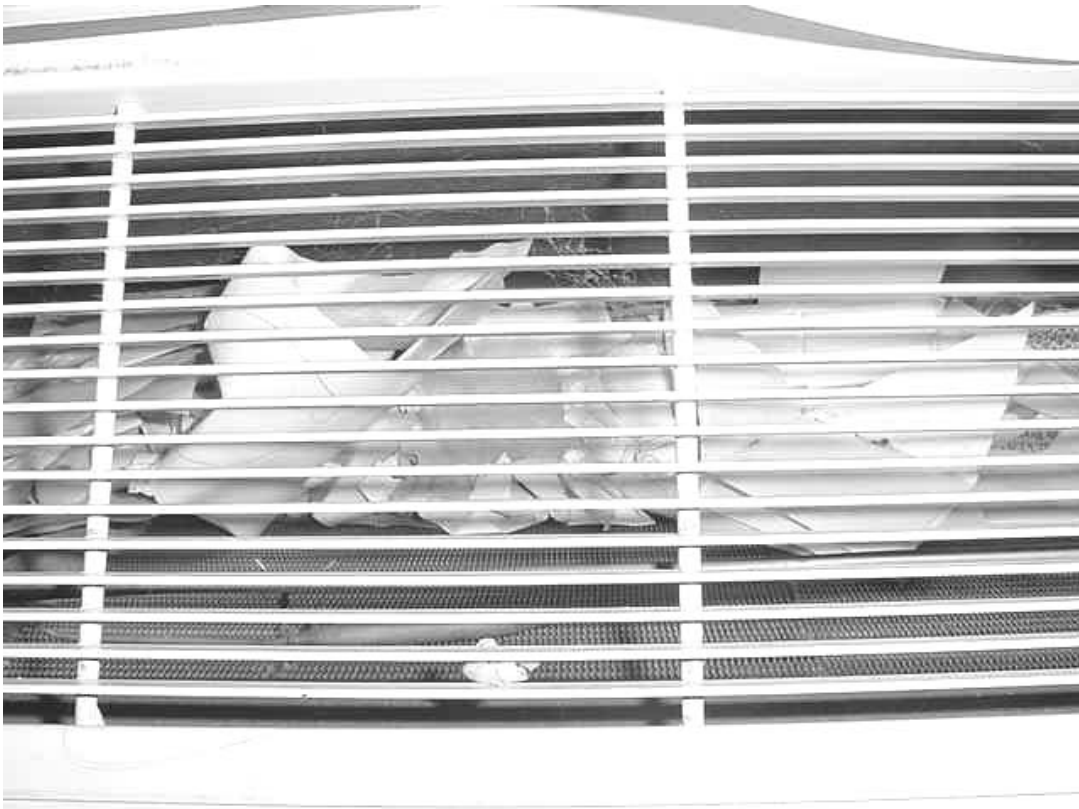
Picture 16

A number of univents had accumulated dirt, dust and debris within their air handling chambers, on coils, fans and other components (see Picture 16). These conditions can be attributed to the fact that no means for inserting filters exist in these univents. In order to avoid univents serving as a source of aerosolized particulates, the air handling sections of the univents should be regularly cleaned. However, without filters, dirt, dust and debris can easily collect within the units.

Trash and Debris inside Univent Air Diffuser near Heating Element
